PROTECTING USONIA
A HOMEOWNER'S AND SITE MANAGER'S RESOURCE FOR UNDERSTANDING AND ADDRESSING
COMMON PRESERVATION CONCERNS IN FRANK LLOYD WRIGHT'S USONIAN HOME

A THESIS

SUBMITTED ON THE 29TH DAY OF APRIL 2018
TO THE DEPARTMENT OF PRESERVATION STUDIES
IN PARTIAL FULFILLMENT OF THE REQUIREMENTS OF
THE SCHOOL OF ARCHITECTURE
OF TULANE UNIVERSITY
FOR THE DEGREE
OF
MASTER OF PRESERVATION STUDIES

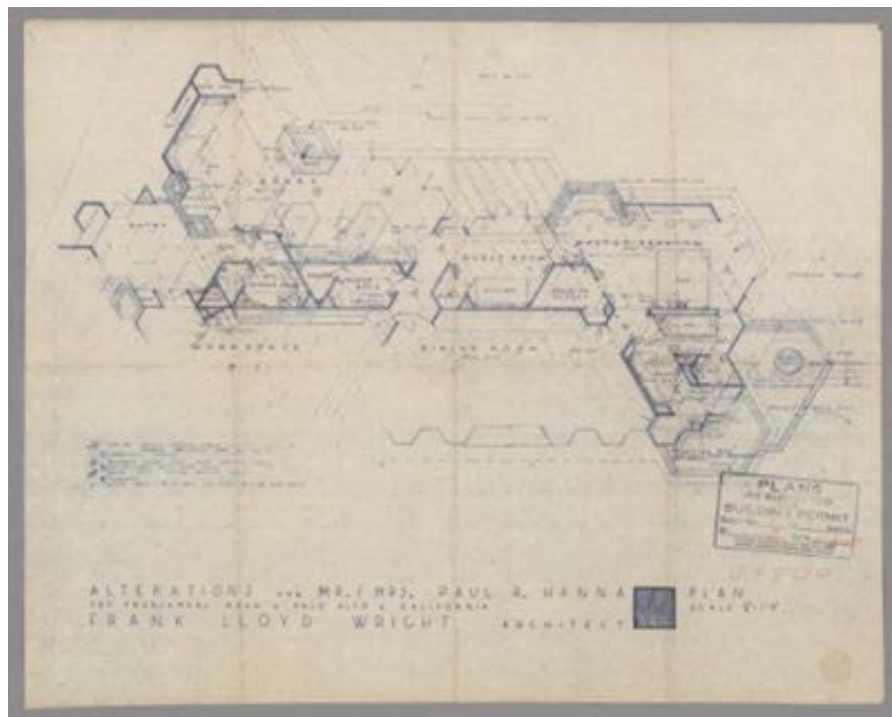
Fig. 3 Plan - alterations for Mr. & Mrs. Paul R. Hanna (No. 149 with Building Dept. submitted stamp.)

The fourth type of Usonian home is the Hexagonal Usonian, which is exemplified most clearly in the Hanna House, also referred to as the honeycomb house. Wright began experimenting increasingly with different shapes and thought about how utilizing these shapes as modules would affect the inhabitant. Wright felt that the angles in a hexagon were more

conducive to human movement than a strict 90-degree square system.²⁹ Actually, the hexagonal design is based both on the triangle and the hexagon and features the angles 60 and 120.³⁰

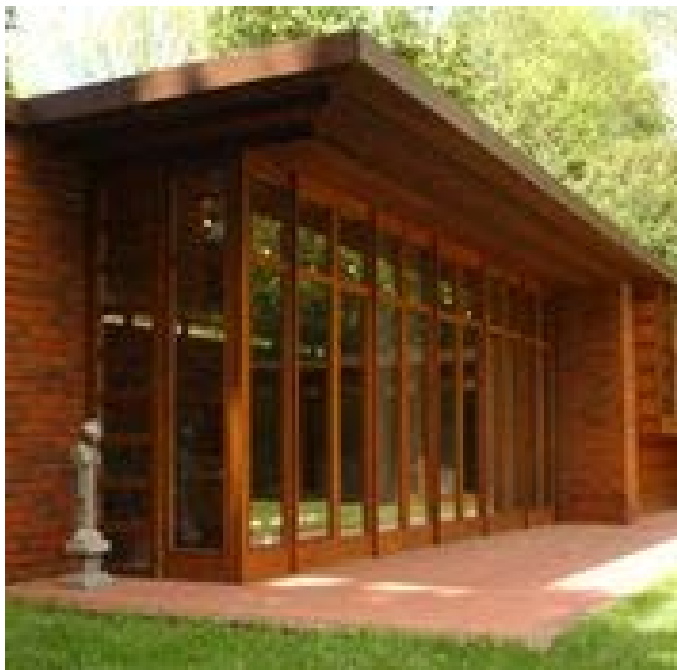
Fig.4 Image of Herbert Jacobs House Photo by Joe Koshholleck

The home's board and batten interior and exterior "sandwich" walls are Ponderosa Pine (board) and Redwood (batten). The brick piers and walls are the main structural support for the home. Brick is also the material that forms the masonry core of the home that houses the kitchen and divides the public and the private sections of the house. The ceiling heights of the home vary and are higher in the living and dining areas and lower in the private spaces. The higher ceiling heights allow for clerestory windows. The Jacobs' house does not feature a perforated design, however, the street facing clerestory windows provide strategic light infiltration, as well as privacy.³⁴

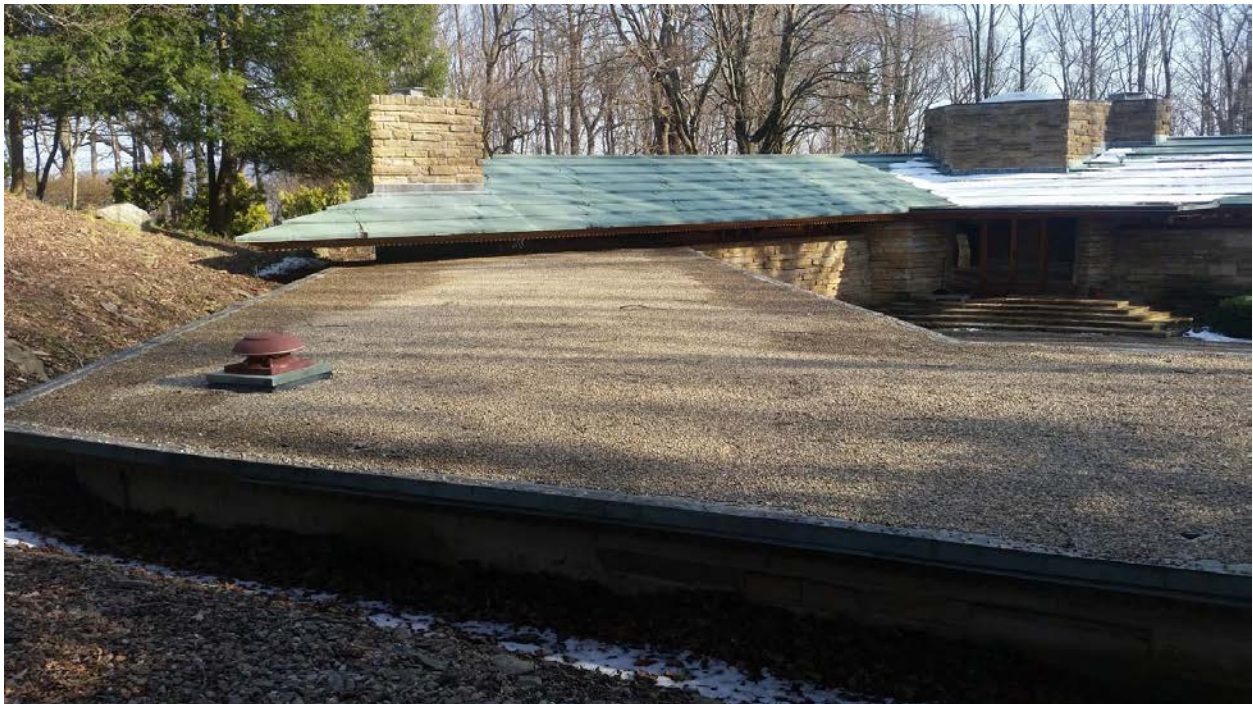
Fig.6 Kentuck Knob Carport Roof
Source: Kentuckknob.com

The skylight openings at the West and South portions of the house, and the carport and art studio all have flat roofs with gravel-ballast roof systems and 2 x12 roof support systems with decking covering the beams. These sections of the roof feature triangular copper downspouts that move water away from the roof. The pea gravel that holds down the ballast system is the medium through which this water is moved.

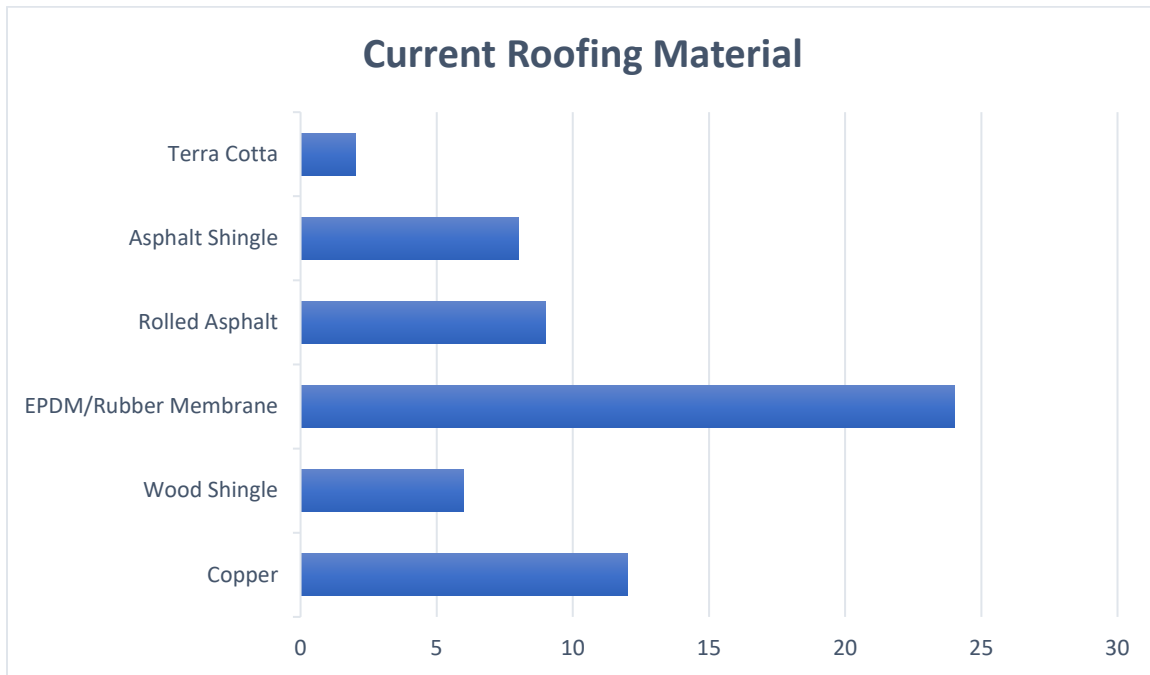
Copper 21.1%
Wood Shingle 10.5%
EPDM/Rubber Membrane 42.1%
Rolled Asphalt 15.8%
Shingle Asphalt 14%
Terra Cotta 3.5%
PVC Membrane 1.8%
Acrymax Acrylic Membrane 1.8%
Dex-O-Tex Built Up Roofing 1.8%

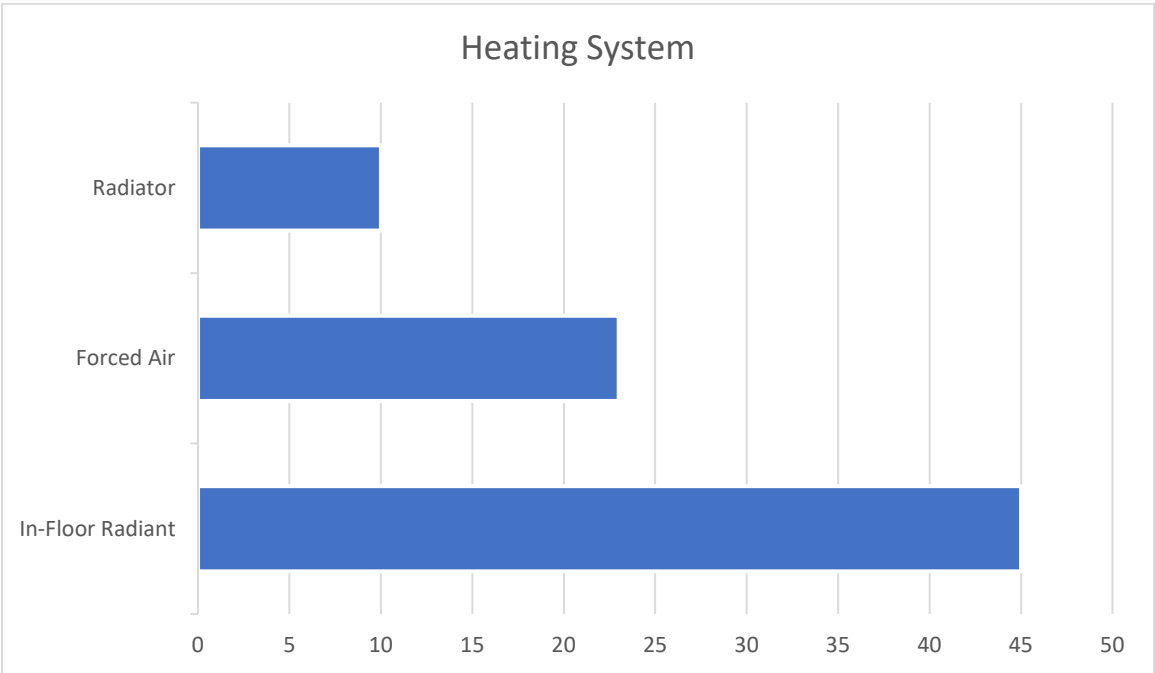
Most Common Heating Systems

- In-floor Hydronic Radiant Heat 76.3%
- Forced Air 39%
- Radiator 16.9%

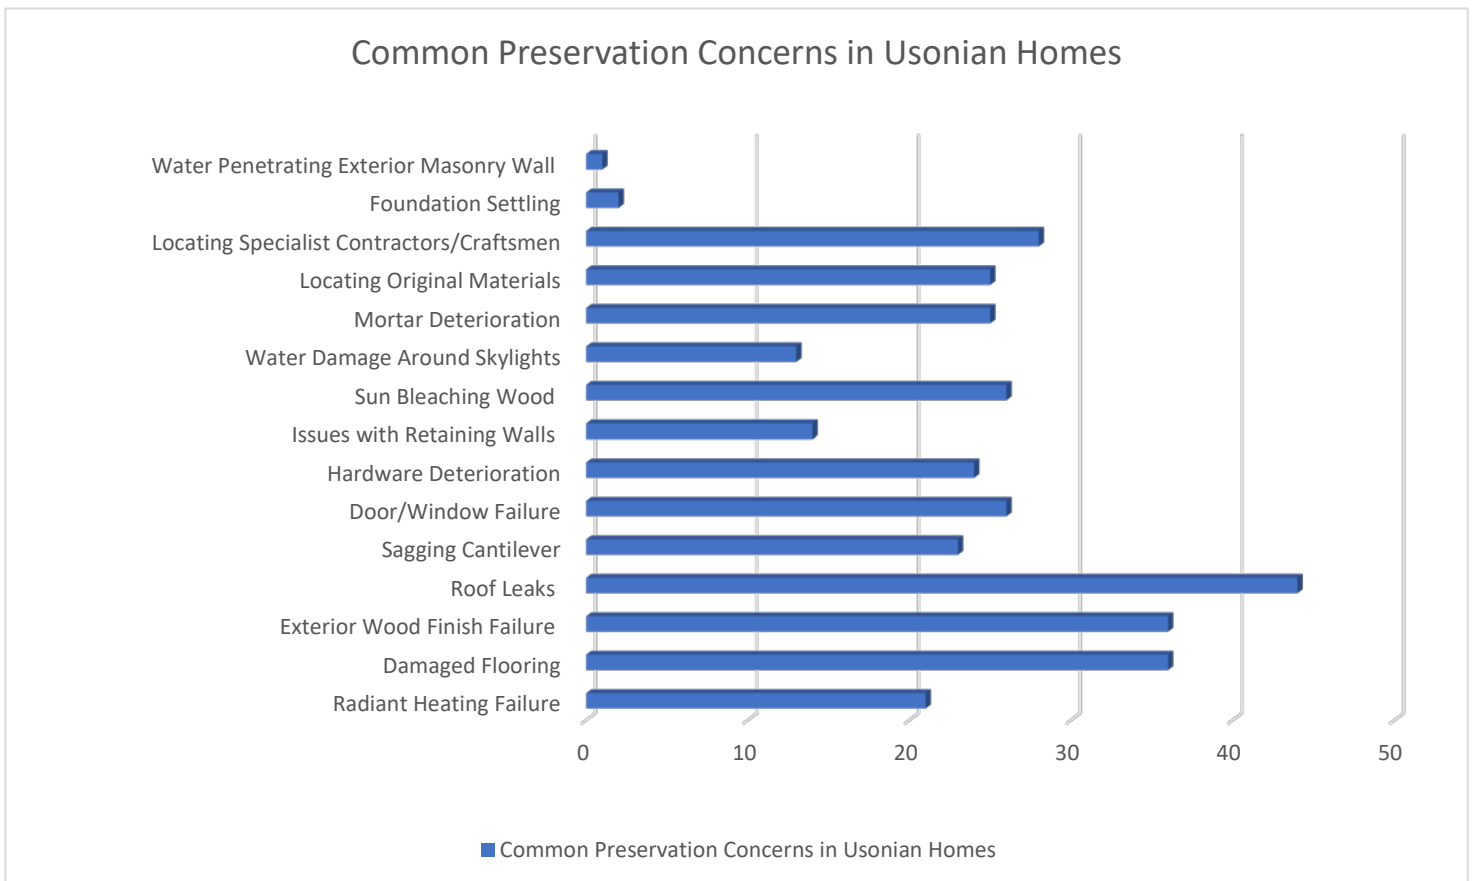
Radiant Heating System Failure 35%
Cracked or Damaged Flooring 60%
Wood Treatment/Finish Failure 60%
Hardware Failure 40%
Door and Window Failure 43.3%
Sagging/Failing Cantilever Roof Structure 38.3%
Leaks in Roof 73.3%
Failure of Retaining Walls 23.3%
Sun Bleaching of Woodwork 43.3%
Locating Original Materials for Restoration Projects 41.7%
Locating Specialist Contractors/Craftsmen 48.3%
Water Intrusion and Damage via Skylights 21.7%
Mortar Deterioration 41.7%
Textile Block Deterioration 1.7%

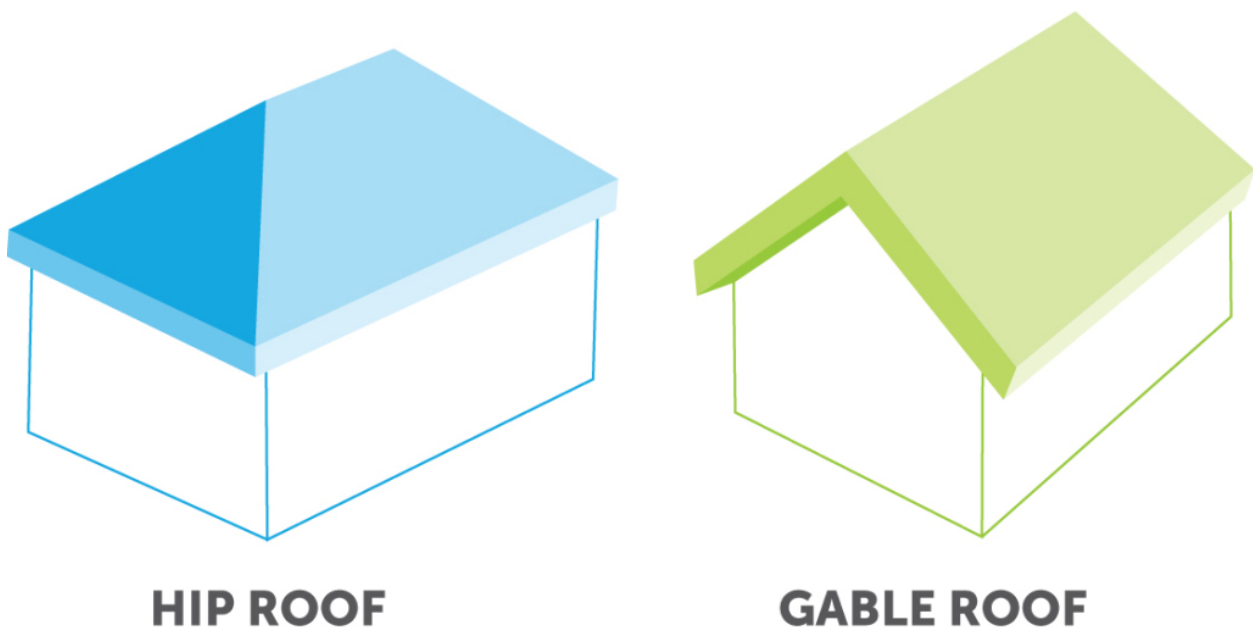
Fig.9 Illustration of Hip and Gable Roof Forms
Source: www.marbex.co.uk

Of the survey respondents, 86% indicated that they have flat roofs, 33% gable. Of those, 52% indicated that their homes only feature flat roofs. Complex roofs, with a combination of either flat and hipped or flat and gable totaled at about 37%, with a very clear favor of a combination of flat and hipped. Only 11.5% indicated either hipped or gable as the sole roof style. Understand the slope, angles, how materials are inter-connected, and how water is or is not shed from a roof are important tools in identifying potential problems.

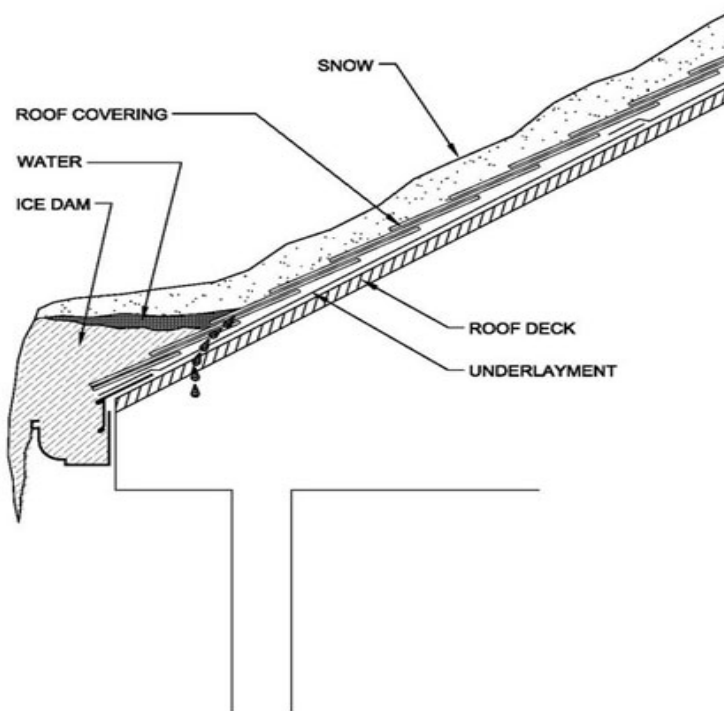
Fig. 10 Graphic of Ice Damming
Source: www.akgeneralroofing.com

Ice-damming is another concern in homes in colder climates. Ice damming is the concentration of ice on the eaves of a roof, typically evident by a collection of large icicles. Damming is usually caused by a combination of poor ventilation and heat escaping and warming the eaves of a section of a roof. This heat melts the underside of a snow load, which then can freeze. Additionally, natural water pooling at these edges can have the same effect. Water retention from ice-damming can damage shingles and cause leaks.⁸⁸

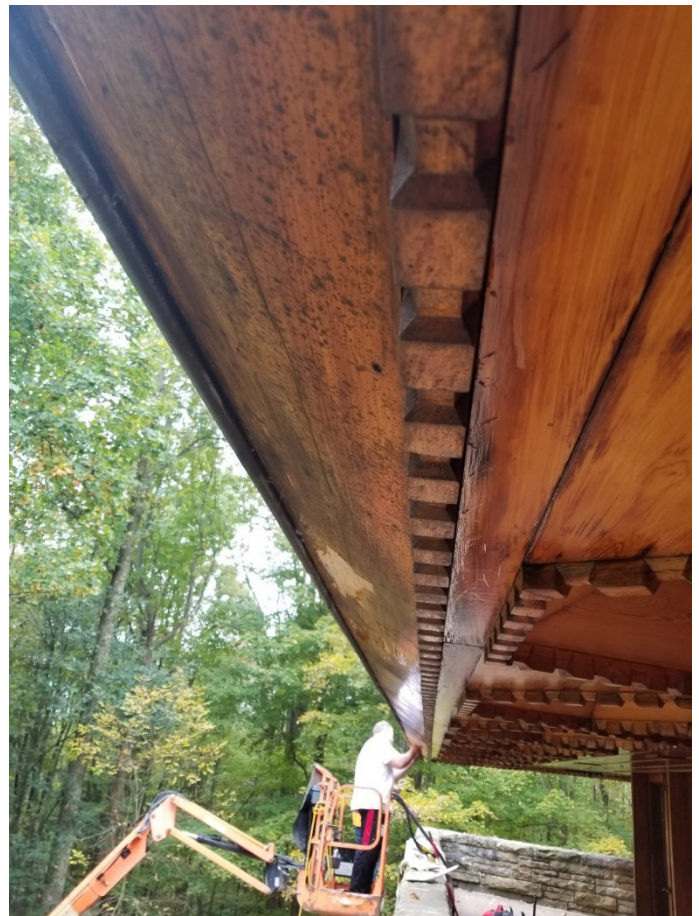
Wood is a material that, even with natural rot resilience, is susceptible to weathering and natural aging and deterioration, as are their finishes. The combination of direct UV rays, wind, and precipitation act to degrade the finishes on the wood of these homes. As mentioned before, it is especially prevalent on the south and eastern facades due to increased exposure. One such example of a failed finish material was the varnish that was placed on the southern side of Kentuck Knob.

*Fig. 11 Image of Finish Failure and Soiled Cypress Fascia Board
Source: Image by Author*

Once the finish material begins to fail, moisture will find its way into the wood causing a

myriad of issues including discoloration, cracking due to freeze and thaw, and rot. Additionally, when finishes fail the wood becomes more susceptible to insect infestation.

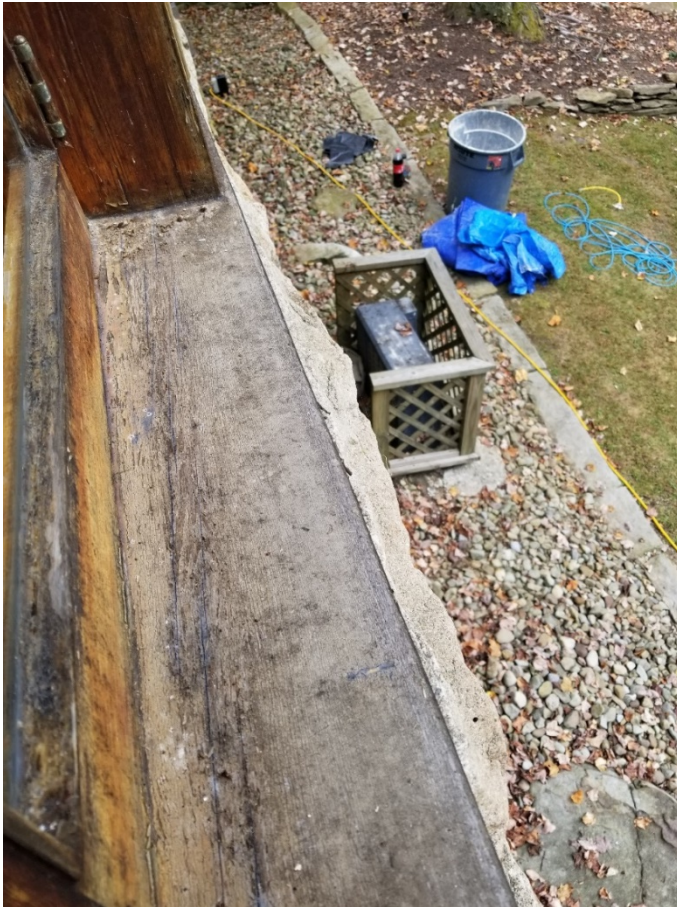
Over time the varnish began to discolor and crack under the sun, and with increased exposure due to this failure, the rain began to beat directly against the fascia and windows causing discoloration.

It is vital to understand that finishes are the sacrificial coating and will eventually fail given enough time. As such, the continued monitoring and implementation of consistent maintenance of these coats is vital.
